Critical Lift At Petro-Canada Plant Smooth As Silk

Domson Engineering & Inspection were contracted to provide lift engineering services at Petro-Canada's Oakville refinery during a shutdown occurring this month. The first major lift, however, occurred on August 11, 2002 involving a new 110 foot fractionator tower weighing in at 325,000 lbs.

Domson Digest – October 2002

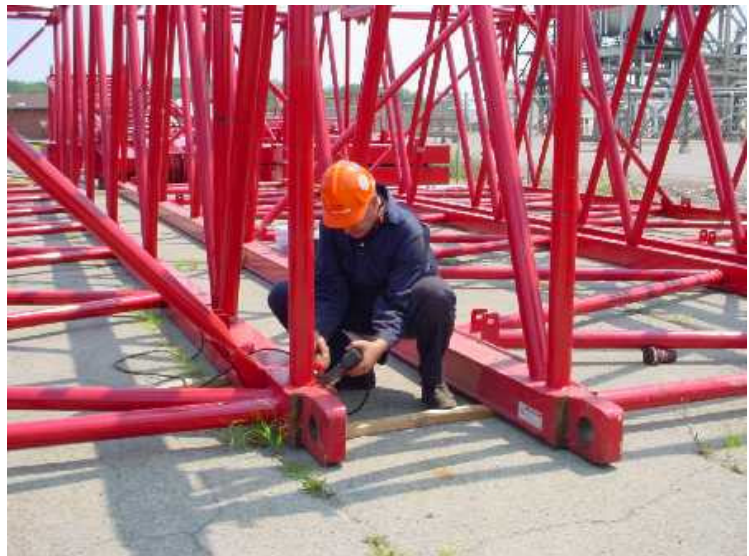
The tower had previously been offloaded and partially dressed while still on the ground and horizontal. Now it needed to be lifted into the vertical position on a temporary pad to allow the crew to finish its construction.

To raise such a large and heavy vessel required the services of a Manitowoc 888 Ringer crane and a Demag AC1200 (500 ton) all terrain crane. With 275 feet of boom on a 45 foot ring and 60 foot square base, the Manitowoc dwarfed its telescopic partner, usually considered to be a pretty large crane in its own right.

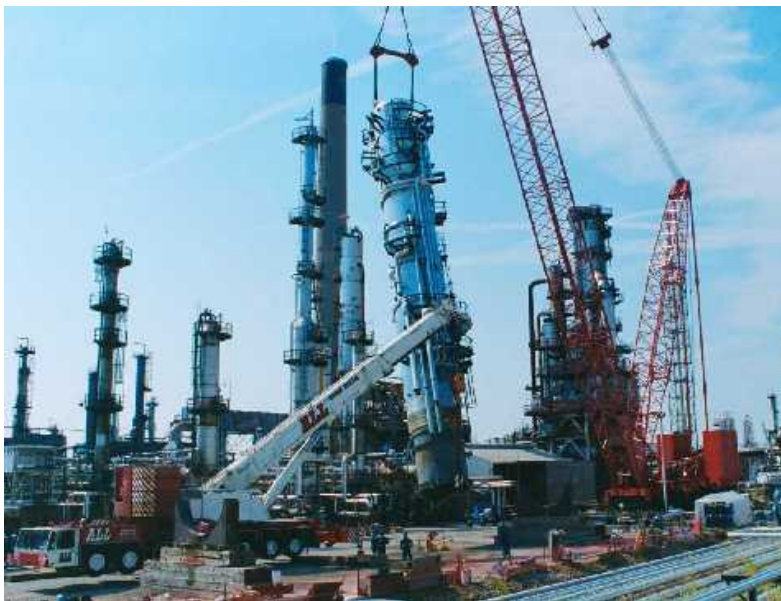
The ringer crane arrived in pieces on approximately 60 flatbed trucks. Before it could be assembled within the plant, it needed to be fully inspected and certified safe for use. Our engineering personnel reviewed the crane configuration with the rental company and determined critical areas that would require testing. A team of our experienced inspectors was then dispatched under the supervision of our engineering staff to examine those areas using magnetic particle and ultrasonic testing. The crane was found to be in excellent condition with only a few minor repairs before being promptly assembled.
